THIRROUL FACADE REPORT: 332-F- 300

Reference:	302 LAWRENCE HARGRAVE DRIVE
Date:	9-12-13
To:	B. MEBBERSON
CC:	COMMITTEE
From:	DICK HARGRAVE
Make:	FACADE
Year of manufacture:	UNKOWN
Serial No	302 LAWRENCE HARGRAVE DRIVE
Inspection Date:	7-12-13
Inspection Site:	302 LH DRIVE
Acceptance Spec;	AS4100 AS1576
Test Specification;	AS1171 PLUS 100% VISUAL AND PHOTOGRAPHY
Material:	AS WELDED/ PAINTED AND SCAFFOLDING, BRICKS AND MORTER
Objective:	N.D.T. ASSESSMENT AND VISUAL OF WHOLE OF STRUCTURE FOR COMPLIANCE TO ABOVE CODES
Testing procedures:	AS PER AS1171 MAG PARTICLE PROCEDURES. 100% VISUAL SCAN.

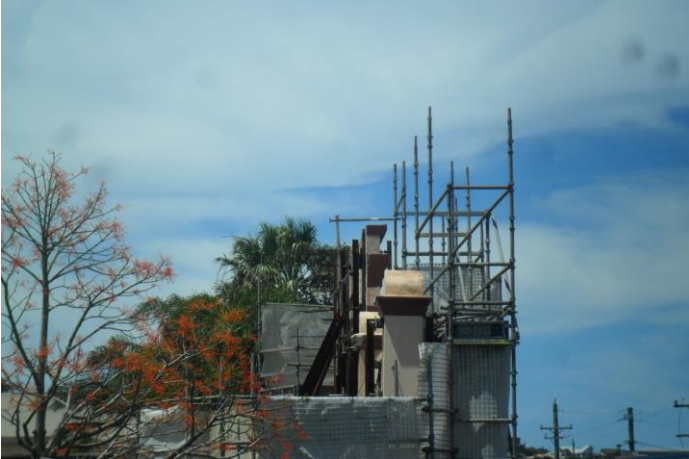
NOTE THE EXTREME LEAN ON THE UPPER FACADE PHOTO (1) AND THE REASON (2) THE LINTEL IS ACROSS BOTH MAJOR COLUMNS AND HAS CAUSED ALL OF THE UPPER SECTION TO SPLIT THROUGH THE MORTAR.

I ESTIMATE THE LEAN TO BE ABOUT 170mm AT THE TOP.

THESE CRACKS ARE VERY SIMILAR TO THE WALL THAT COLLAPSED IN MELBOURNE, I AND OTHERS PREDICTED THE WALL IN MELBOURNE WOULD FALL AS IT DID ONE YEAR LATER, THIS WALL IS NO DIFFERENT. IT WILL HAPPEN!

MY MOTO FOR ALL MY VISITATION SITES, WETHER OF CONSTRUCTION OR EVEN A VISIT TO A PROMOTED TOURIST SITE IS
OBSERVE, ENJOY, REMEMBER.
 THIS SIGHT WAS UGLY TO ITS EXTREME, I DID NOT ENJOY IT, AND I WOULD LIKE TO THINK I WILL FORGET IT SOMEDAY. THIS SITE IS NOT WHAT MOST PEOPLE WOULD OBSERVE ENJOY OR REMEMBER. PERHAPS A DIFFERENT OPPINION WOULD BE SEEN IF IT WAS REMOVED AND TURNED INTO PARKLAND. MY STRONGEST RECOMMENDATION IS THAT IT SHOULD BE REMOVED BEFORE THE DEVIL LETS GO.

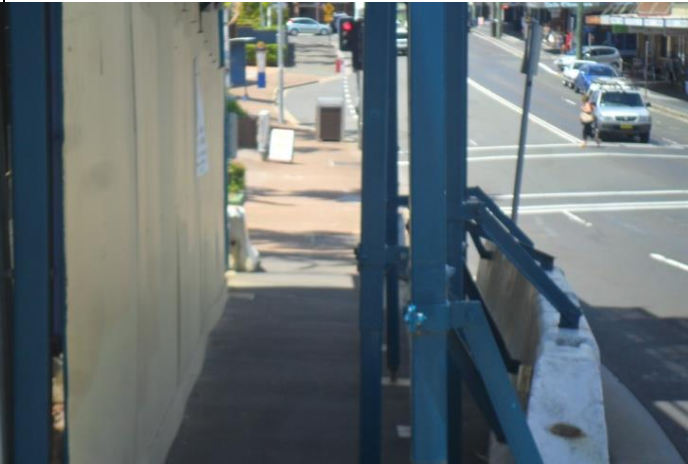
NOTE THE MISALIGNMENT OF THE STEEL SCAFFOLD POSTS (1) AND THE DEPRESSION OF THE FOOTPATH (2) HAS TWO OF THE POSTS SLIPPED OR HAVE THEY BEEN BUMPED BY TRAFFIC. THE POST SHOULD ALSO BE HIGHLIGHTED FOR VISION IMPAIRED AND DIFUSED NIGHT LIGHT. NOTE ALSO THE FOOT PLATES ARE NOT ANCHORED TO GROUND AND THEY SHOULD BE IF ANGLE IS GREATER THAN 3 DEGREE

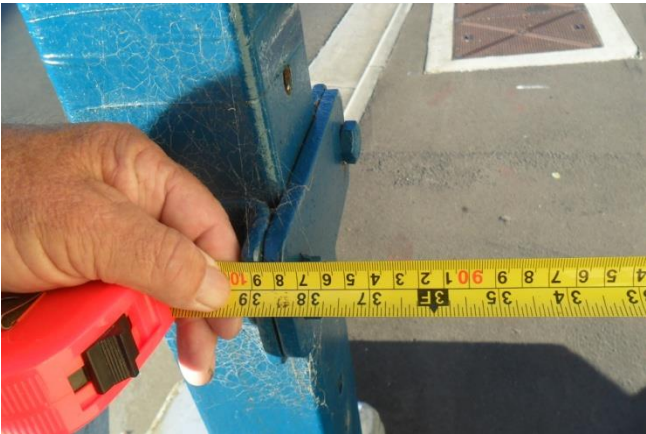
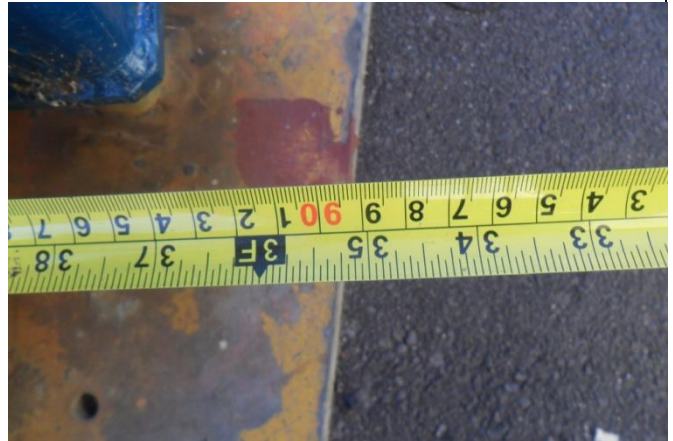
POST 1 AT TOP END

MINIMUM WIDTH? PLEASE READ AS1428 Cl.6.3 a b c AND Fig 2 PAGE 10 .THE DRAWING CLEARLY STATES 1 METRE AS THE MINIMUM NOT 970mm AND THE SPACE IS NOT TO HAVE ANY IMPEDIMENT WITHIN THAT 1M , THAT INCLUDES FOOTPLATE AS SEEN IN PHOTO 1& 2 AT 980mm AT WAIST LEVEL AND 890 AT FOOTPLATE BASE. THE FOOTPLATE IS 110mm INSIDE THE MINIMUM SPACE

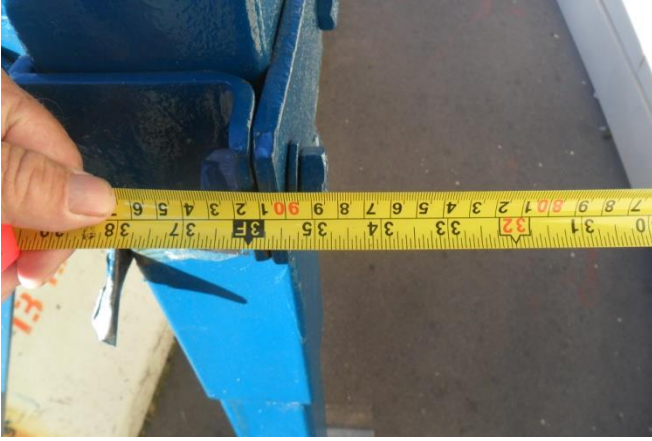
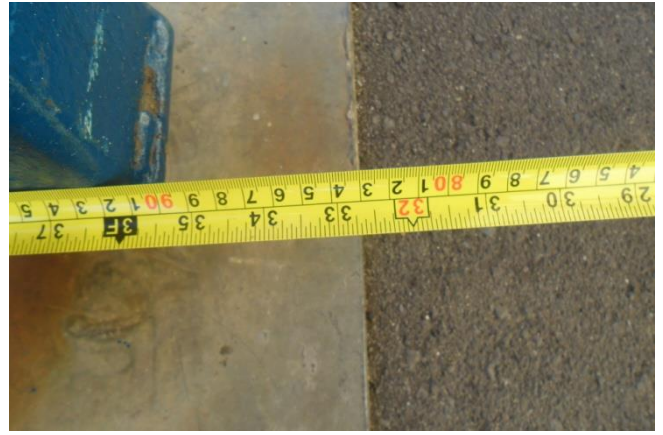
POST 2 NEAR TOP END

POST 2 HAS A MEASUREMENT OF 900mm AT WAIST HIGH BUT AT THE FOOT PLATE IT IS ONLY 830mm WHICH IS CLASSED AS A IMPEDIMENT AND TRIP HAZARD. EVEN A DOOR HANDLE IS A IMPEDIMENT IF IT INVADES THE MINIMUM SPACE. THIS FOOTPLATE IS ALSO 170mm INSIDE ALLOWABLE SPACE
